# HOUSTON INSPECTIONS

**MUD District  
Water Plant GST & HPT  
123 Street  
Houston, TX 77094**

**January 5, 2021**

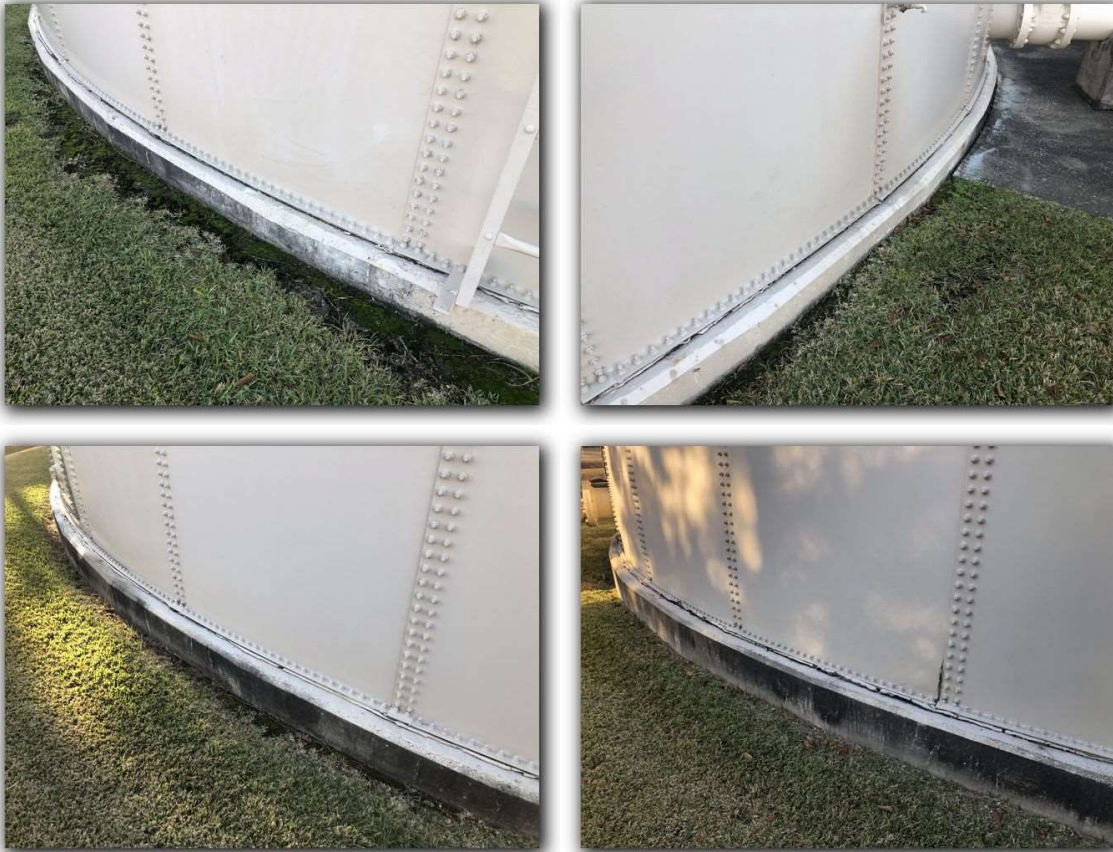
The foundation of the tank appears to be in acceptable condition.

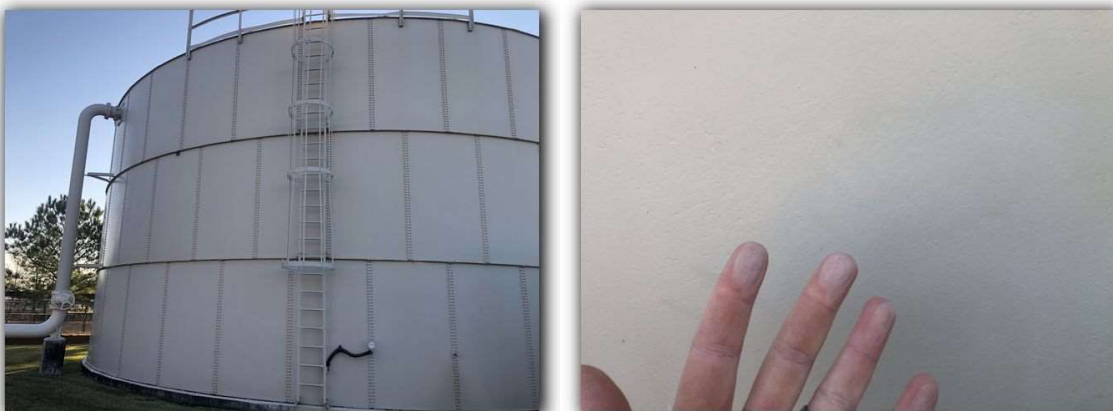
Chalking was noted on the tank at the time of the inspection. This is a common failure in coatings that are exposed to UV light. Typically, this is a cosmetic defect. However, if overcoating is desired then removing the powdery layer prior to applying the overcoat is recommended.

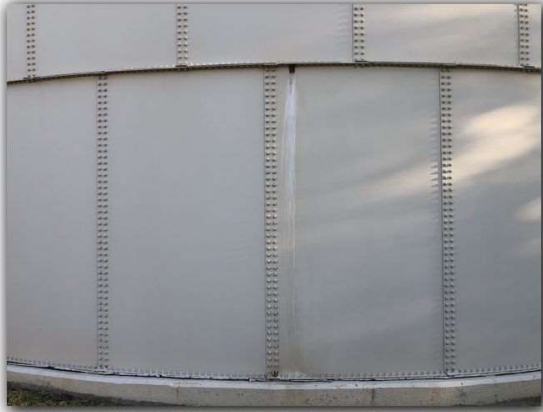
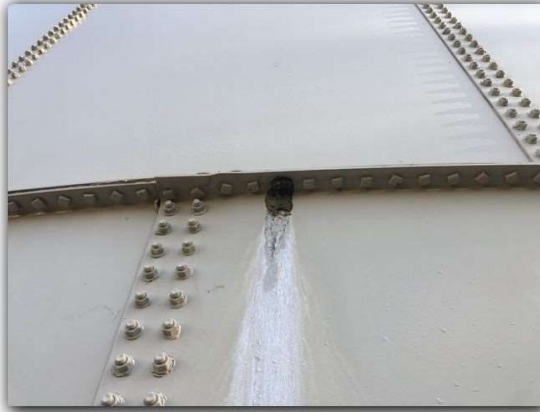
It appears that leaks are present at the tanks sidewall as evident by calcium build up on the exterior of the tank. These areas should be pressure washed to remove the calcium build up, and the leaks should be sealed/repaired.

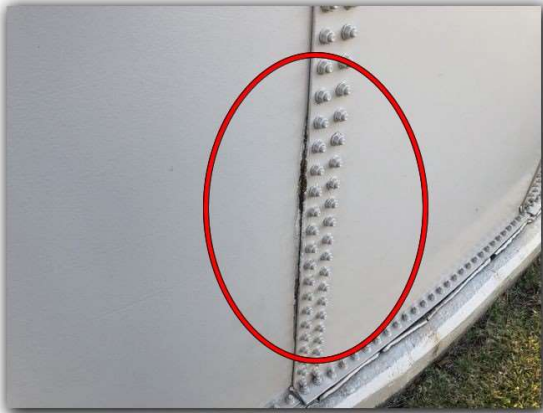
Areas of the sealer fillets along panel edges show evidence of sealer deterioration which is common due to aging of the sealant and weathering from the elements. The sealer provides the coating protection for the panel edges and maintenance of the sealer fillet is critical to the extended life of the tank. As the sealer degrades, corrosion along panel edges may become evident. A maintenance re-caulk service should be performed as the exterior sheet edges become exposed.

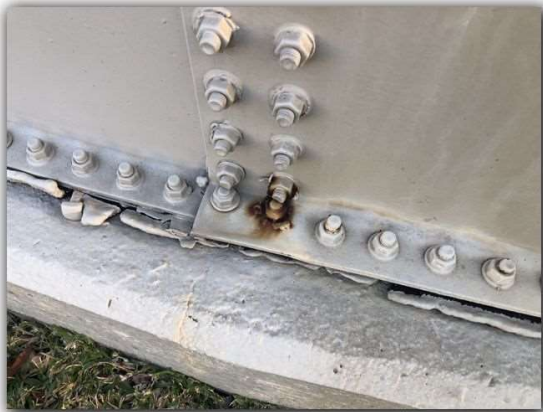
Crevice corrosion (bolts, flanges, metal to metal) was found at areas of the tanks exterior. It is recommended that these areas be cleaned with a wire brush to remove the rust and the areas be properly sealed.

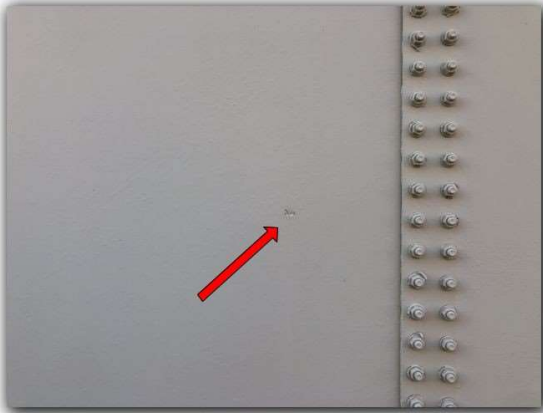
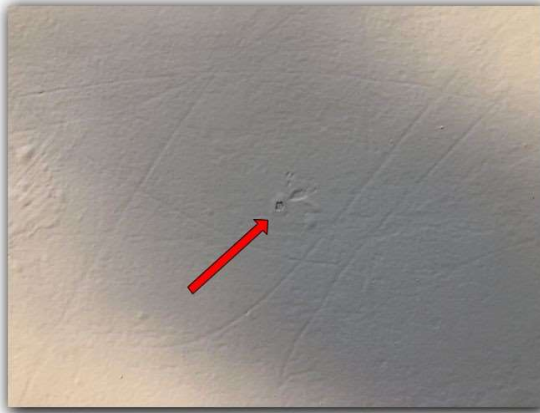
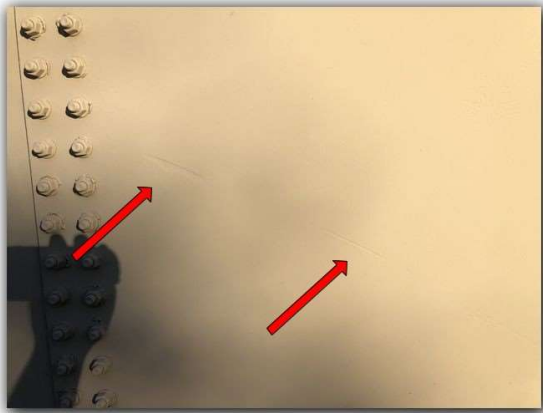
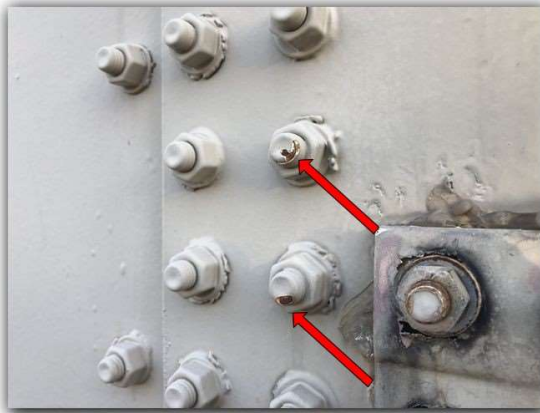
Gouges/chipped areas were noted in the tanks coating system at the time of the inspection. This is caused by mechanical damage to the area. If the substrate is exposed due to the gouge/chip, localized rusting may occur in this area. If the gouge or chipped area is down to the substrate material, it is recommended that the area be sanded down to the bare substrate and the coating be reapplied to prevent corrosion from occurring.

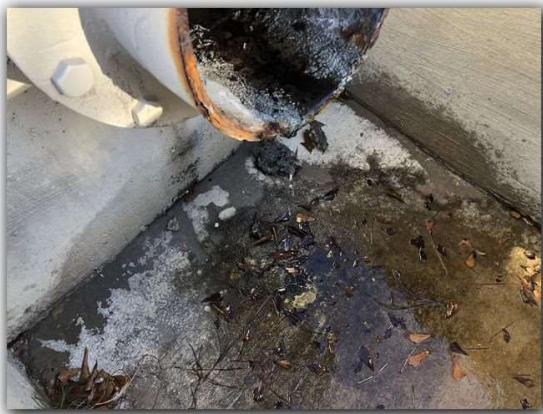
Water was leaking from the overflow drain at the time of the inspection.

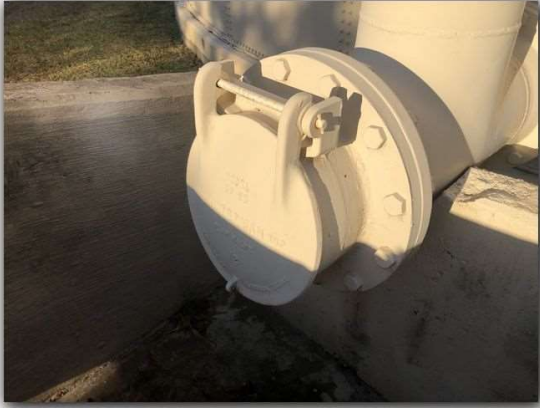
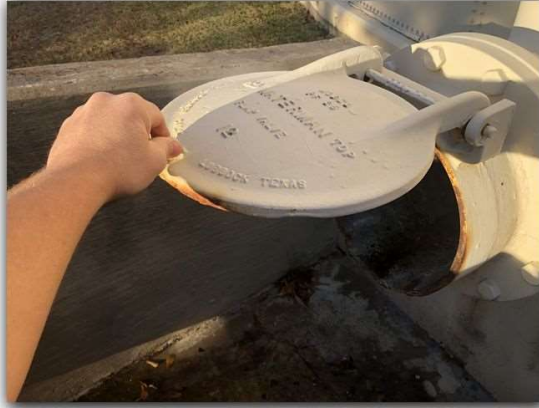
The drain flap is present and was operational during the inspection.

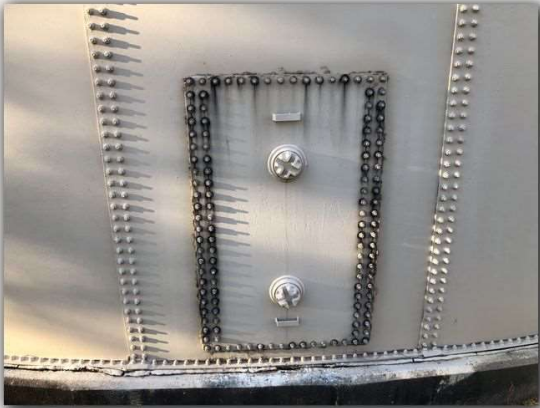
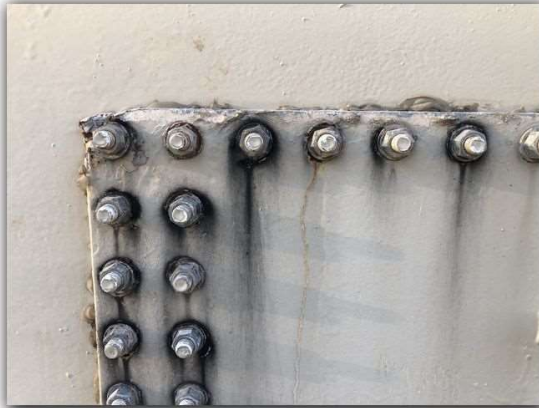
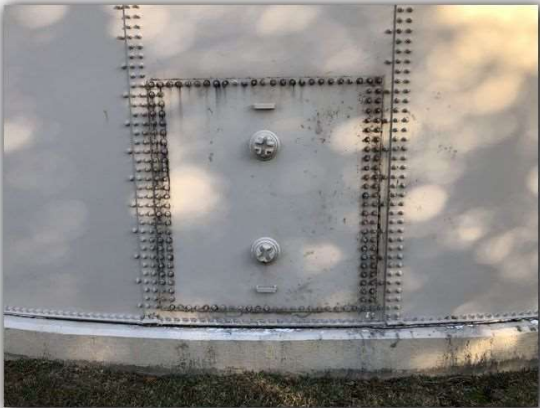
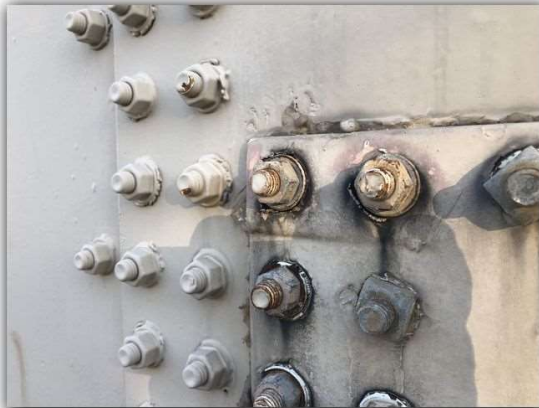
No major defects noted at manway. Minor crevice corrosion was noted at the bolts at the manway.

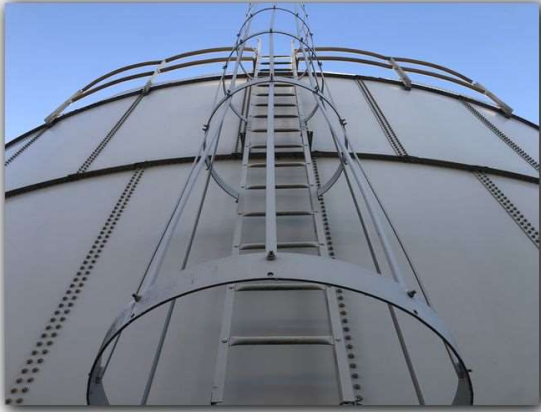
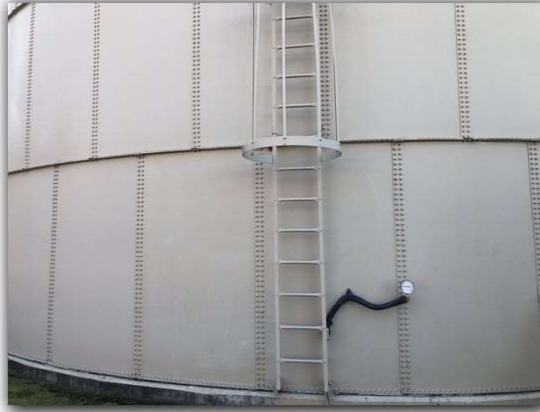
The exterior tank ladder is present with a cage. The ladder was performing its intended function.

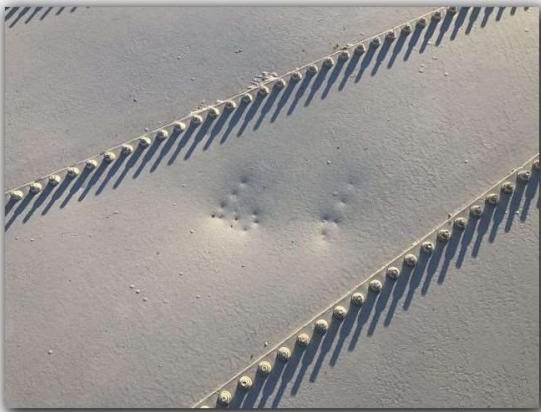
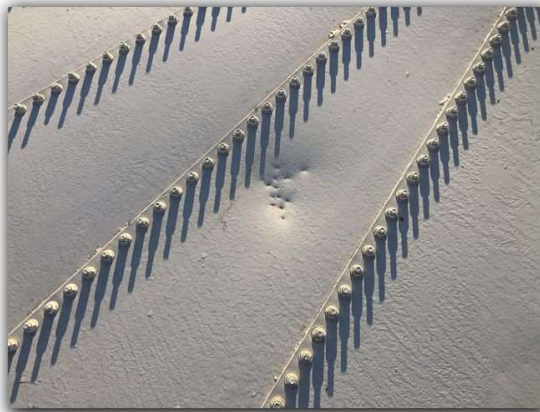
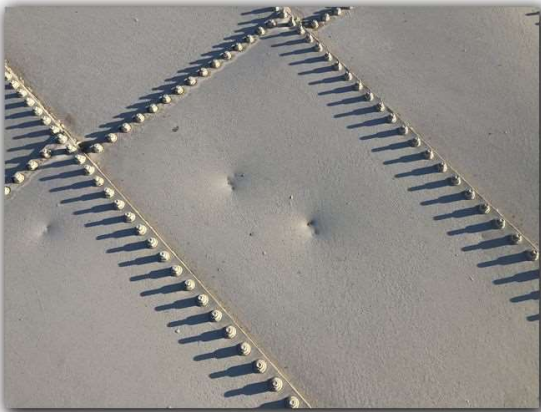
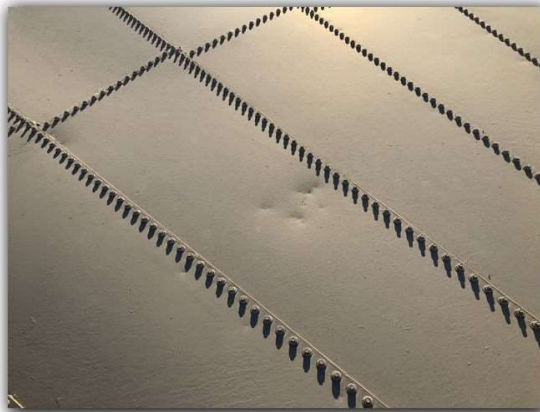
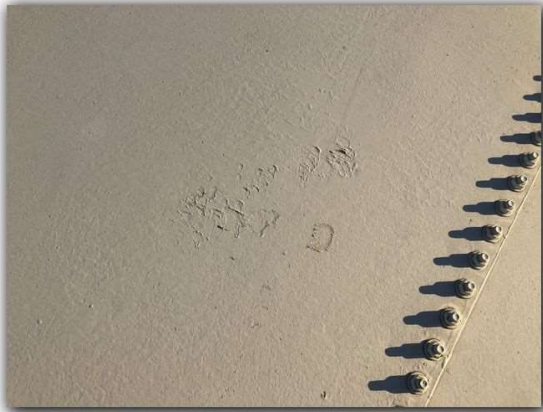
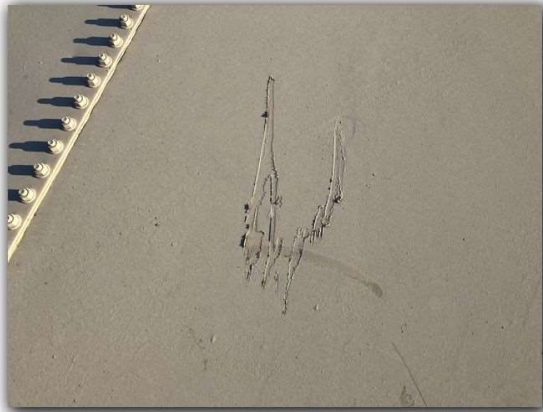
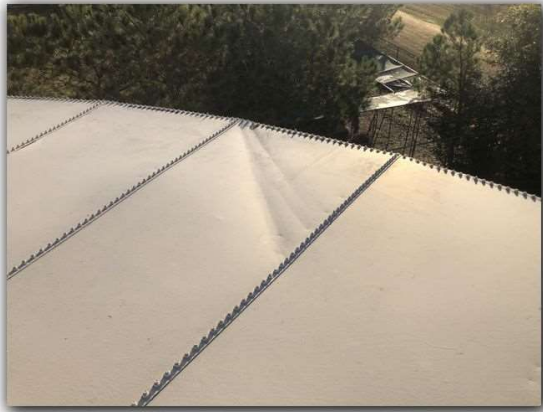
Gouges/chipped areas were noted at the tanks roof at the time of the inspection. This is caused by mechanical damage to the area. If the substrate is exposed due to the gouge/chip, localized rusting may occur in this area. If the gouge or chipped area is down to the substrate material, it is recommended that the area be sanded down to the bare substrate and the coating be reapplied to prevent corrosion from occurring.

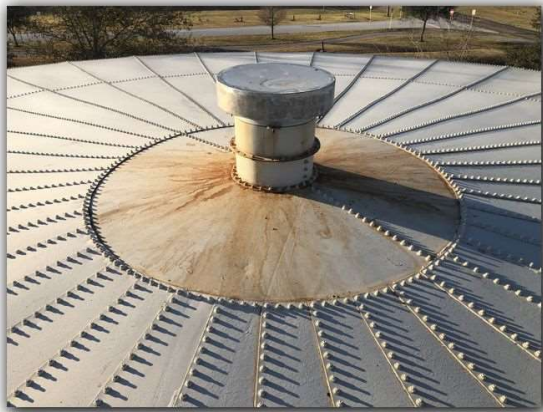
Rust stains were noted on the surface of the tank coating. The stains are caused by an item rusting in the area and bleeding onto the coating. If repairs are desired, it is recommended to replace the item that is rusting and bleeding onto the coating. The stains can be cleaned by sanding down and over coating the area.

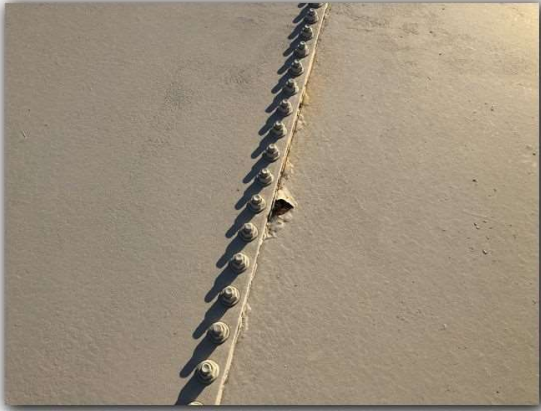
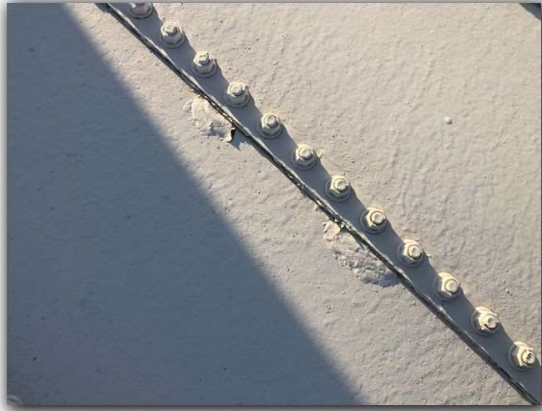
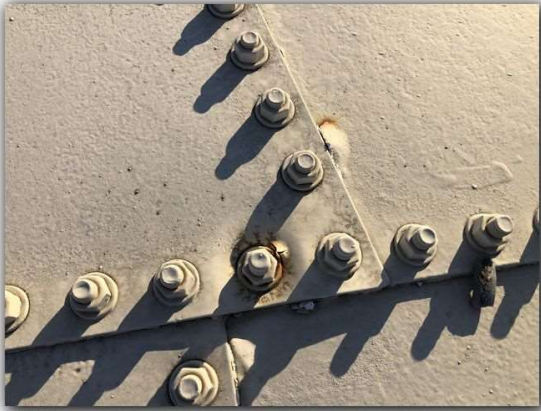
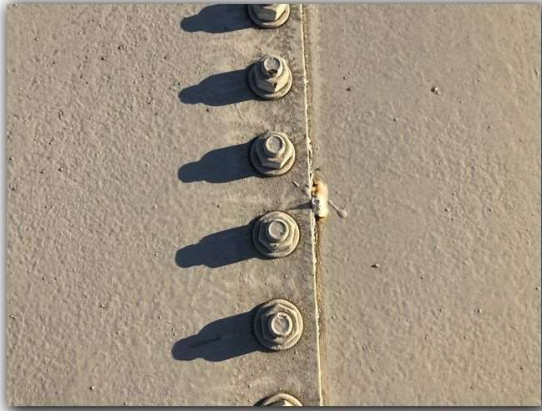
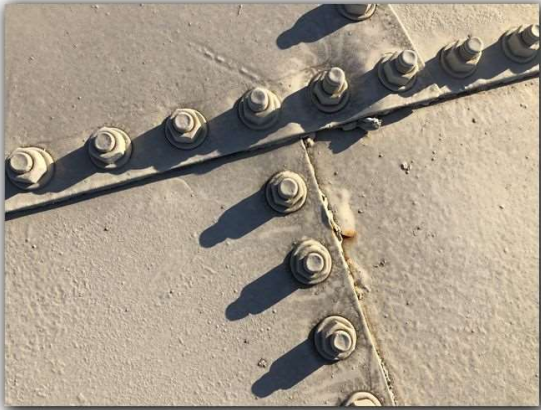
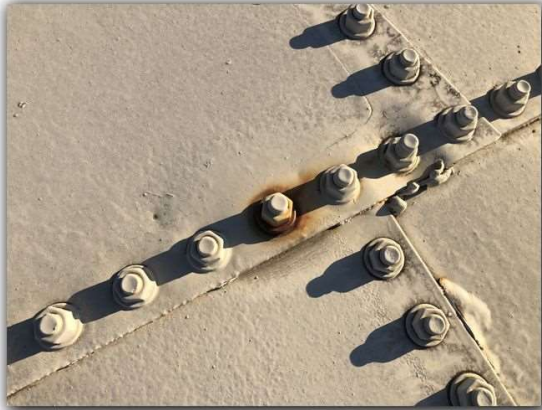
Crevice corrosion (bolts, flanges, metal to metal) was noted at the seams of the roof. Areas of the sealer fillets along panel edges show evidence of sealer deterioration which is common due to aging of the sealant and weathering from the elements. The sealer provides the coating protection for the panel edges and maintenance of the sealer fillet is critical to the extended life of the tanks roof. As the sealer degrades, corrosion along panel edges may become evident. A maintenance re-caulk service should be performed as the exterior sheet edges become exposed.

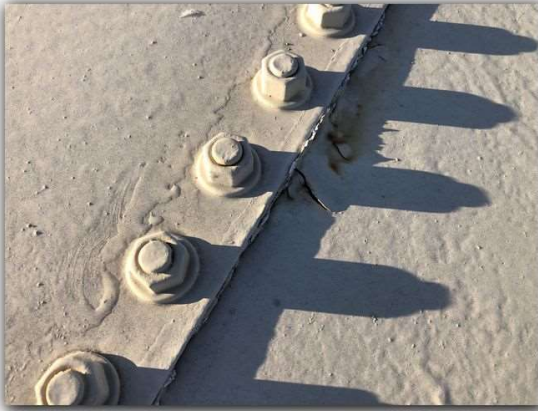
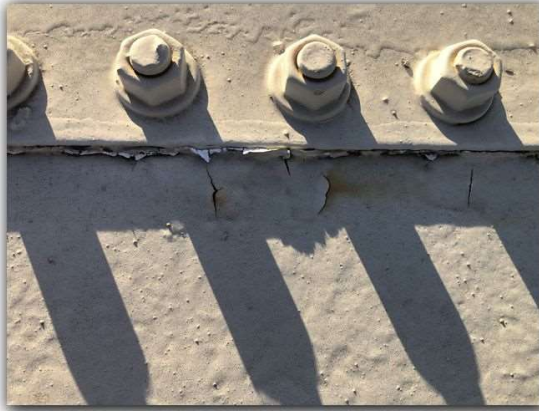
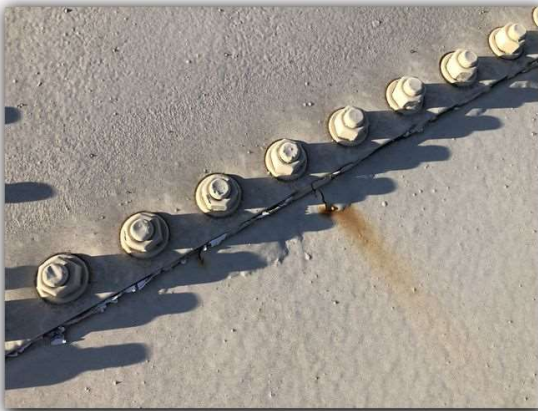
Visible cracks were noted in the tanks coating system. These cracks may either penetrate down to the substrate, or just penetrate through a single coat of the system. This is typically caused by aging, movement in the substrate material, or applying the coating system to thick. Absorption and desorption of moisture can also cause this defect. It is recommended that the coating system be removed and replaced.

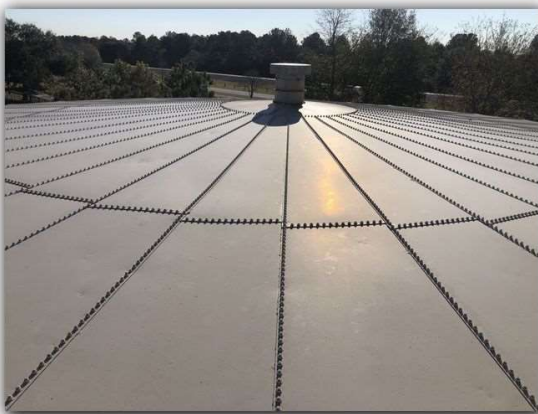
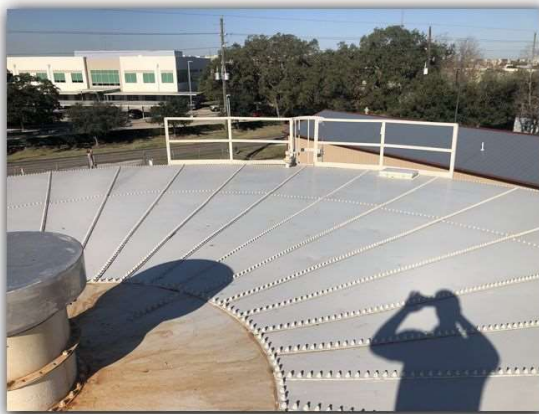
There is no non slip material installed at areas of the roof surface that are commonly walked on for maintenance/inspection purposes. Recommend installing a non slip surface at all areas of the roof that are commonly accessed.

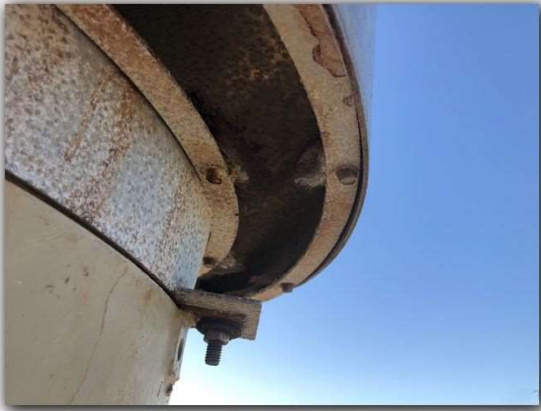
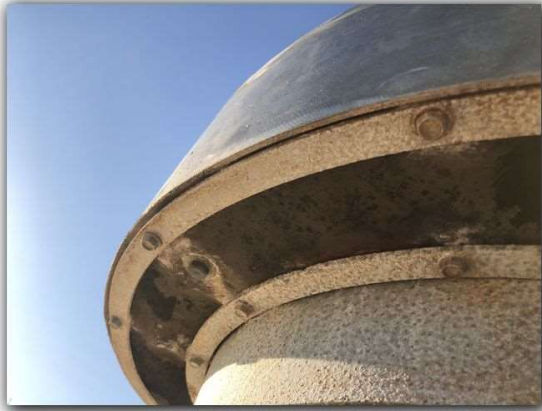
Damaged and missing screens were found at the roof vents. Recommend installing the vent screens.

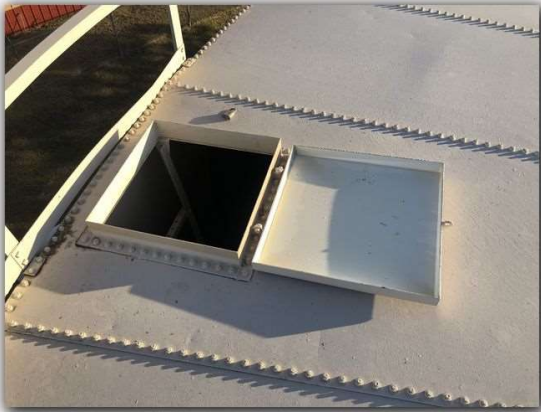
A gasket is not installed at the tank roof hatch. Recommend installing the gasket at the roof hatch.

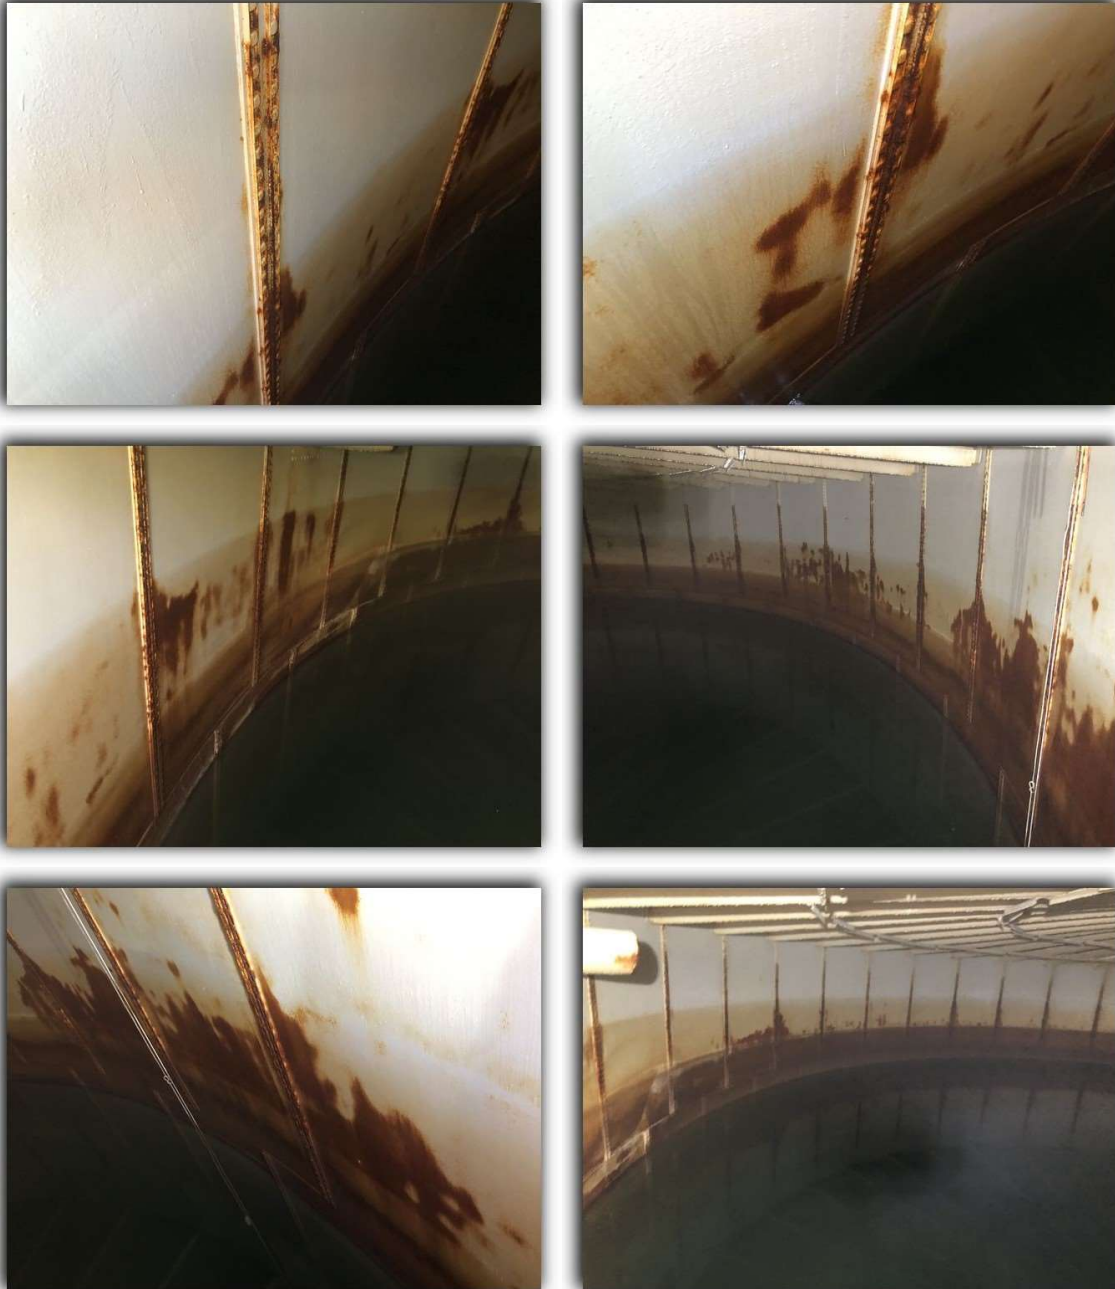
Overall, the interior of the tank was in poor condition. Rust/corrosion was noted at various areas inside of the tank. Crevice corrosion was noted at the interior seams of the tank. It is recommended that the interior seams be re-sealed and all areas of corrosion on the tanks interior be cleaned and re coated.

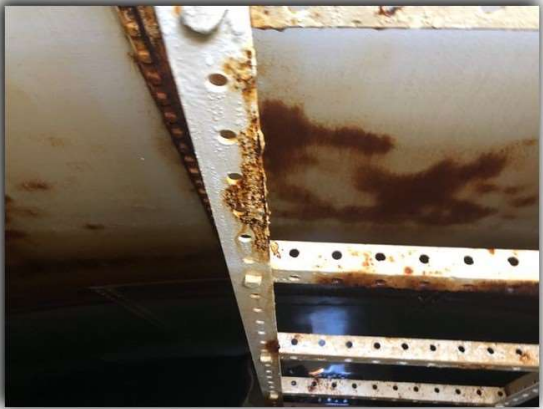
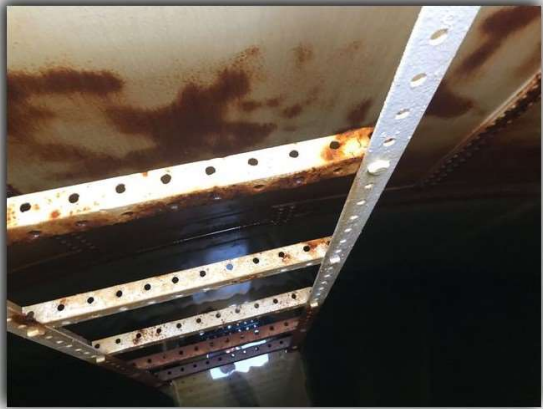
Corrosion was noted at the interior ladder. It is recommended that the corrosion be cleaned and re coated. If areas of corrosion at the interior ladder are beyond repair, it is recommended that these items be replaced.

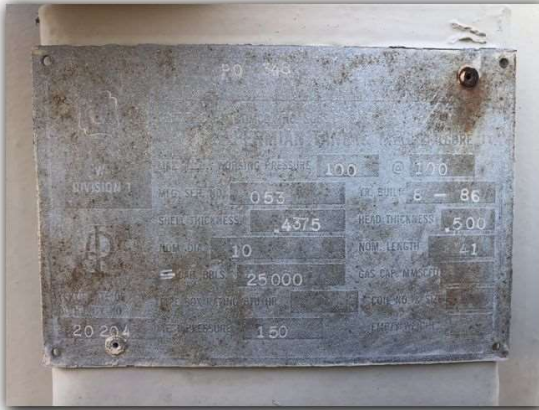
Permian Tank & MFG.

Length: 41'

Diameter: 10'

Head Thickness: .500"

Wall Thickness: .4375"

Max Working Pressure: 100 PSI @ 100 F

Serial #: 053

Year Built: 1986

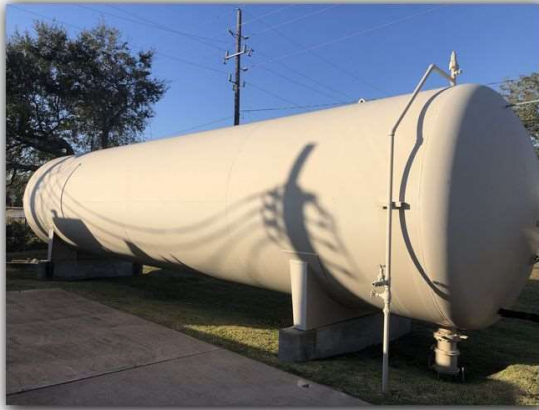
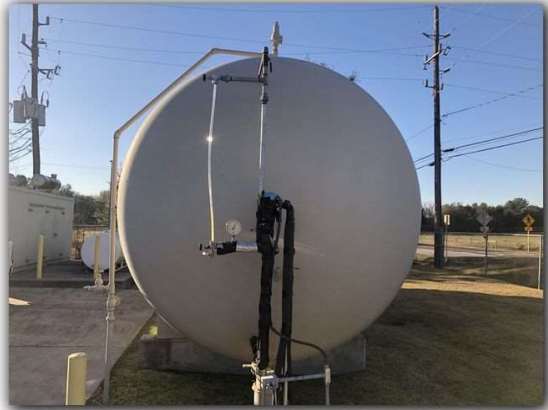
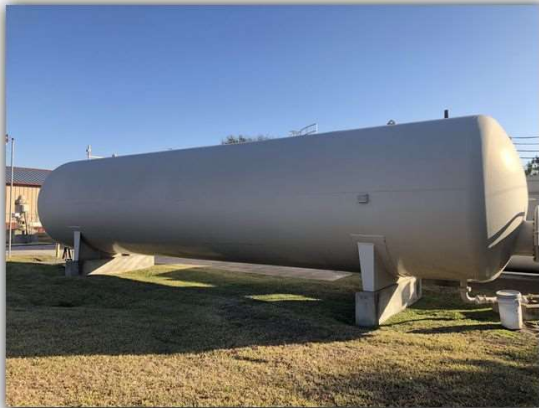
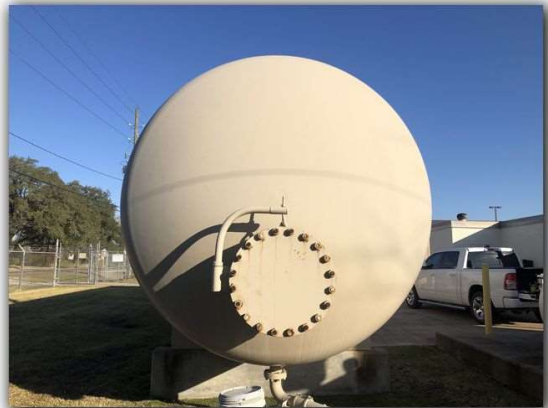
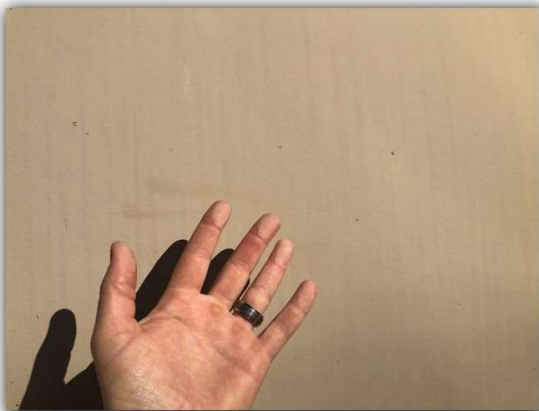
Chalking was noted on the tank at the time of the inspection. This is a common failure in coatings that are exposed to UV light. Typically, this is a cosmetic defect. However, if overcoating is desired then removing the powdery layer prior to applying the overcoat is recommended.

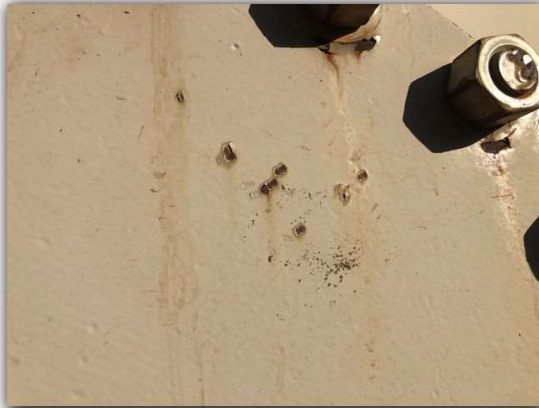
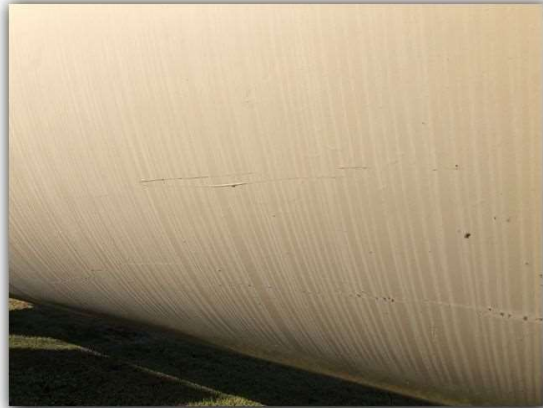
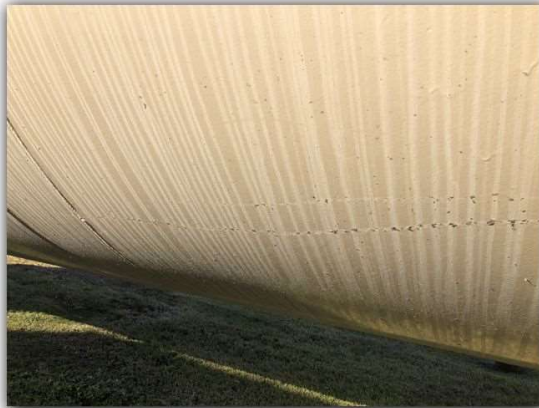
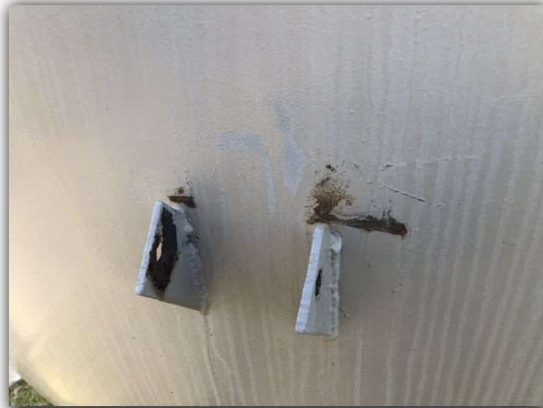
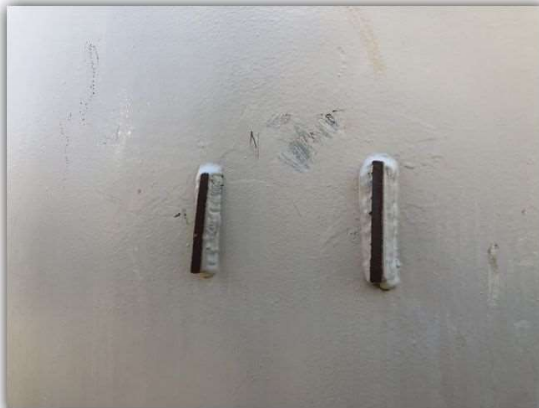
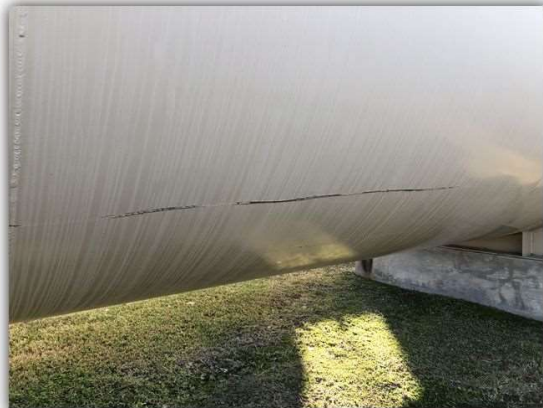
Gouges/chipped areas were noted in the tanks coating system at the time of the inspection. This is caused by mechanical damage to the area. If the substrate is exposed due to the gouge/chip, localized rusting may occur in this area. If the gouge or chipped area is down to the substrate material, it is recommended that the area be sanded down to the bare substrate and the coating be reapplied to prevent corrosion from occurring.

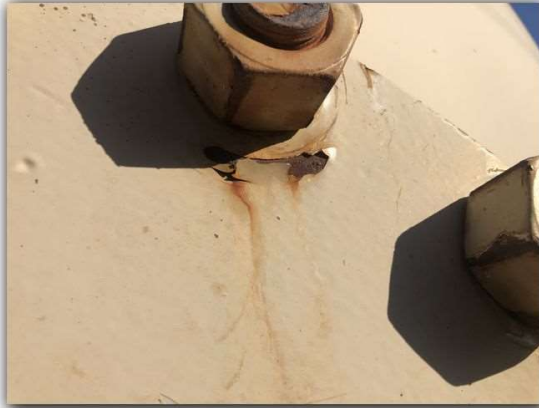
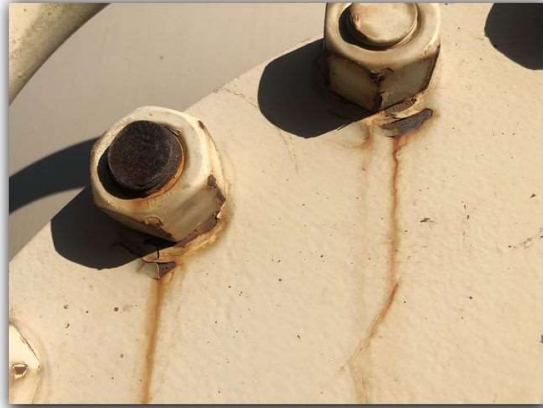
Flaking of the coating material was noted on the tank at the time of the inspection. This defect is typically caused by poor surface preparation of the substrate prior to applying the coating.

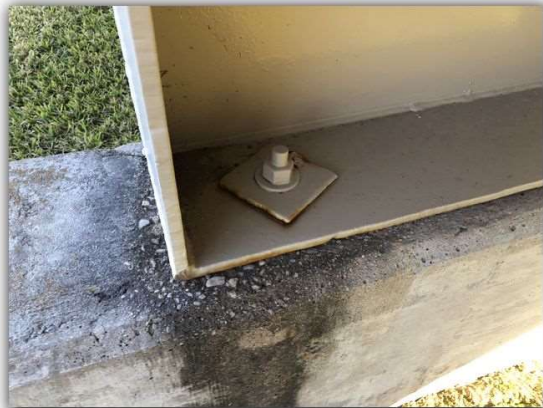
Crevice corrosion (bolts, flanges, metal to metal) was noted at the tank footings. It is recommended that these areas be cleaned with a wire brush to remove the rust and the areas be properly sealed.

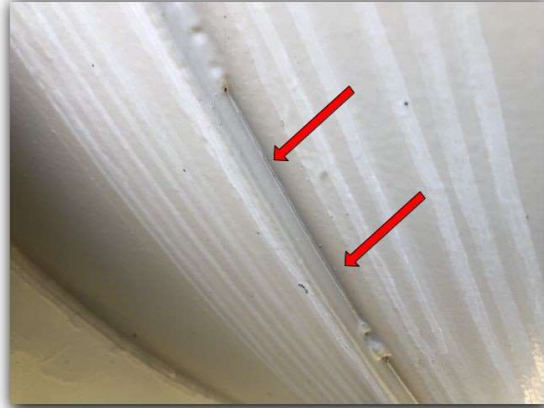
Visible cracks were noted in the tanks coating system at the footings. These cracks may either penetrate down to the substrate, or just penetrate through a single coat of the system. This is typically caused by aging, movement in the substrate material, or applying the coating system too thick. Absorption and desorption of moisture can also cause this defect. It is recommended that the coating system be removed and replaced.

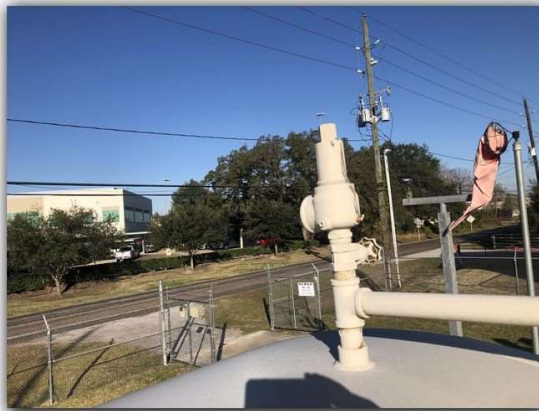
A pressure device is present at the high pressure tank.

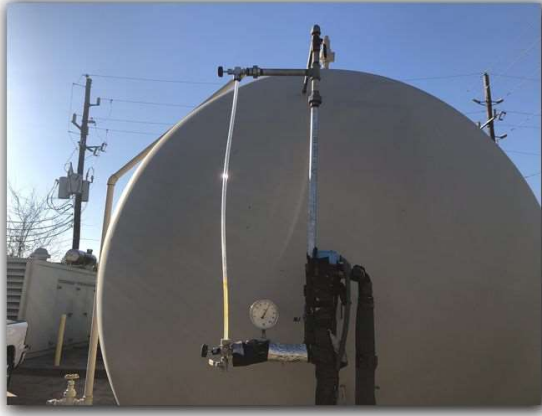
The pressure gauge and air water devices are present with no visible deficiencies.

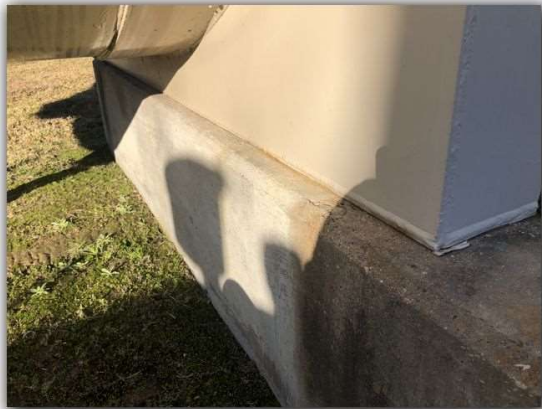
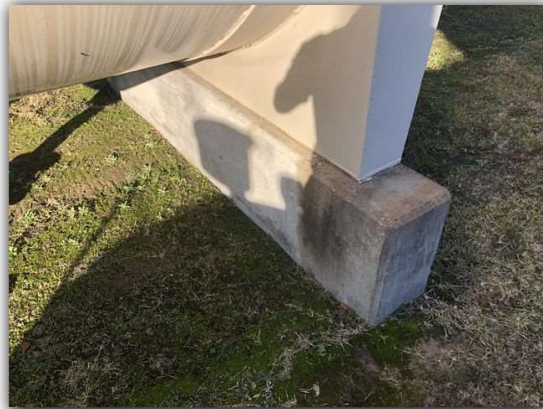
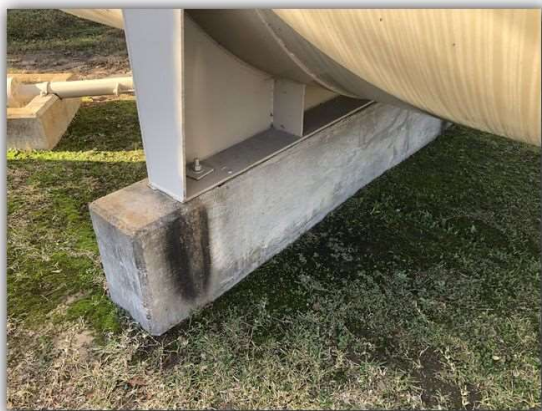
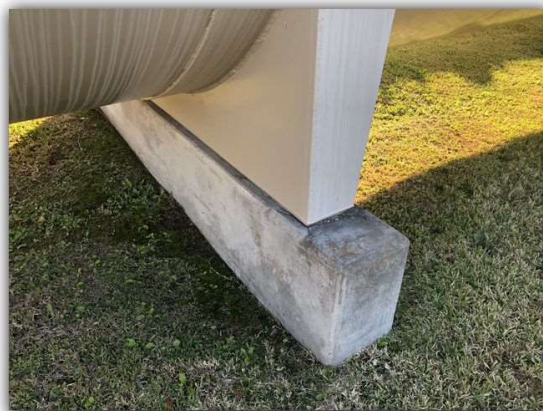
The foundation of the tank appears to be in acceptable condition.

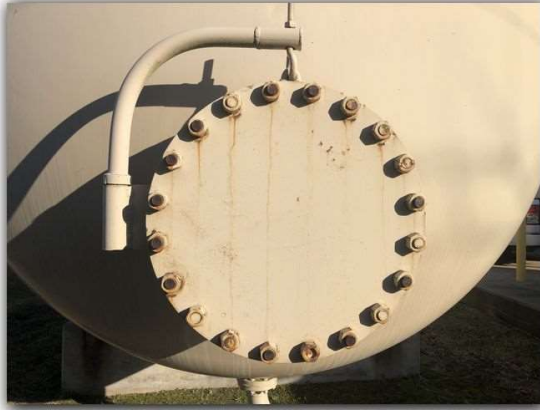
Crevice corrosion (bolts, flanges, metal to metal) It is recommended that these areas be cleaned with a wire brush to remove the rust and the areas be properly sealed.

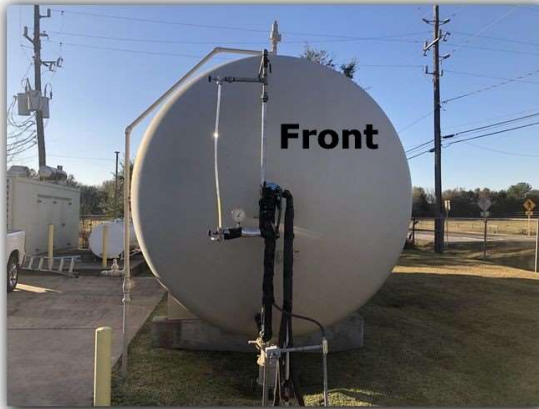
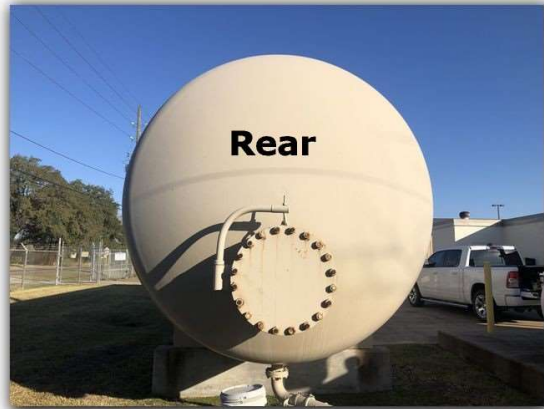
.45	.43	.33	.33	.46
.45	.46	.45	.44	.16
.47	.45	.44	.45	.43

.37	.40	.45	.16	.44
.14	.43	.42	.44	.44
.43	.45	.44	.45	.44

Based on abnormal findings during the ultrasonic readings, it is recommended that an interior inspection of the HPT be performed ASAP.
