# HOUSTON INSPECTIONS

**MUD District  
Water Plant GST & HPT  
123 Street  
Houston, TX 77094**

**January 5, 2021**

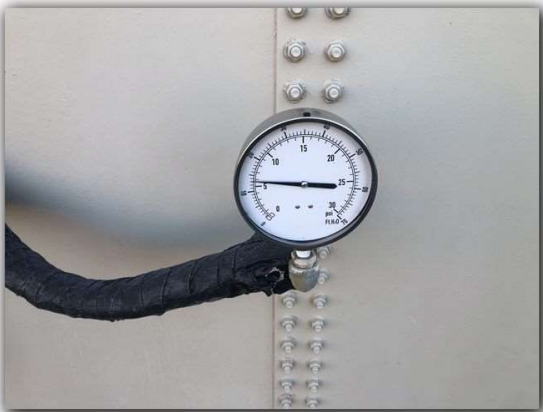
**Water Level Indicator:**

The water level indicator was present at the time of the inspection.

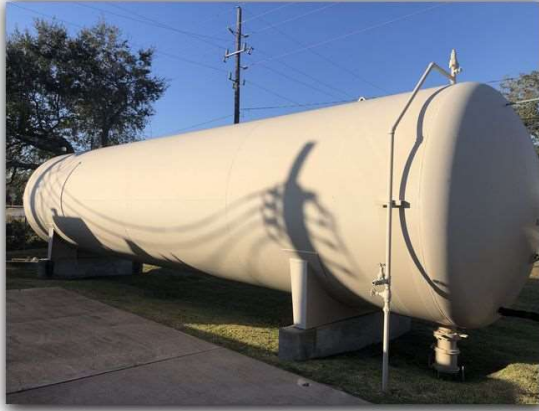
### Tank Location at Facility:

The HPT located at 219 Barker-Clodine Rd at the front of the property was inspected.

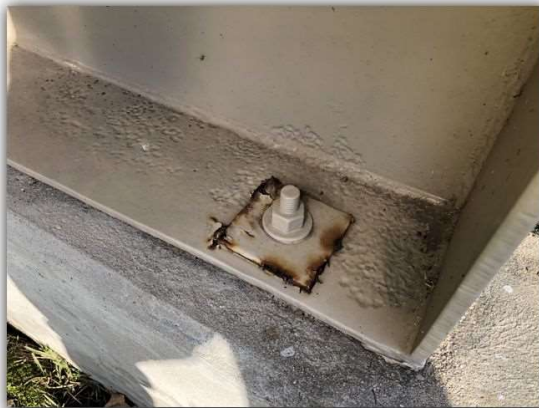
Crevice corrosion (bolts, flanges, metal to metal) was noted at the tank footings. It is recommended that these areas be cleaned with a wire brush to remove the rust and the areas be properly sealed.

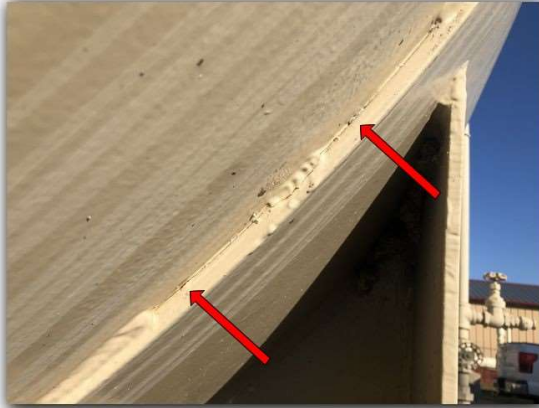
Visible cracks were noted in the tanks coating system at the footings. These cracks may either penetrate down to the substrate, or just penetrate through a single coat of the system. This is typically caused by aging, movement in the substrate material, or applying the coating system too thick. Absorption and desorption of moisture can also cause this defect. It is recommended that the coating system be removed and replaced.
